Guinea Residents Elevate Isabel is Catalyst for Mitigation

Gloucester County, VA – Guinea is a tight-knit community in southeastern Gloucester County. Bounded by the Chesapeake Bay to the east, the York River to the south, and the Severn River to the north, the economic history of the area is a "waterman's" life comprised of fishing, crabbing, and oyster harvesting. With numerous wetlands, streams and creeks in the area, floodplains are prevalent.

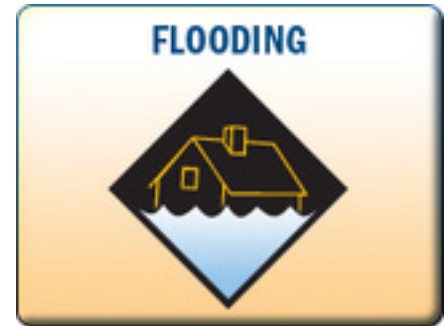
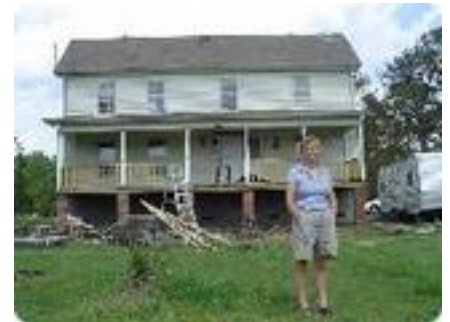
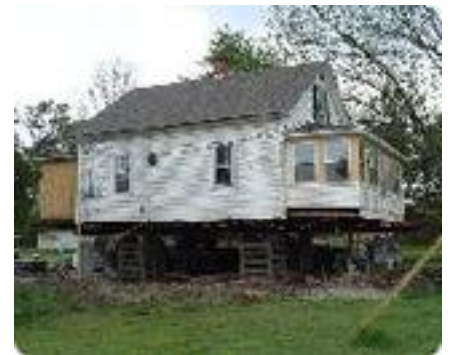
To comply with Gloucester County's floodplain ordinances, the Schultz home was elevated over a crawl space with the first floor above the established Base Flood Elevation. "It would have been irresponsible if we didn't elevate," said Bain Schultz.

A new concrete block foundation wall includes the required flood vents. The vents allow for the free passage of water automatically in both directions without human intervention. The bottom of the openings are no higher than one foot above grade underneath the flood vents.
